100 & 300 AREA UNIT MANAGER MEETING MINUTES

Groundwater and Source Operable Units; Facility Deactivation, Decontamination, Decommission, and Demolition (D4); Interim Safe Storage (ISS); Field Remediation (FR); Mission Completion; and 100-K Sludge Treatment Project and 100-K Facility Demolition and Soil Remediation Projects

April 10, 2014

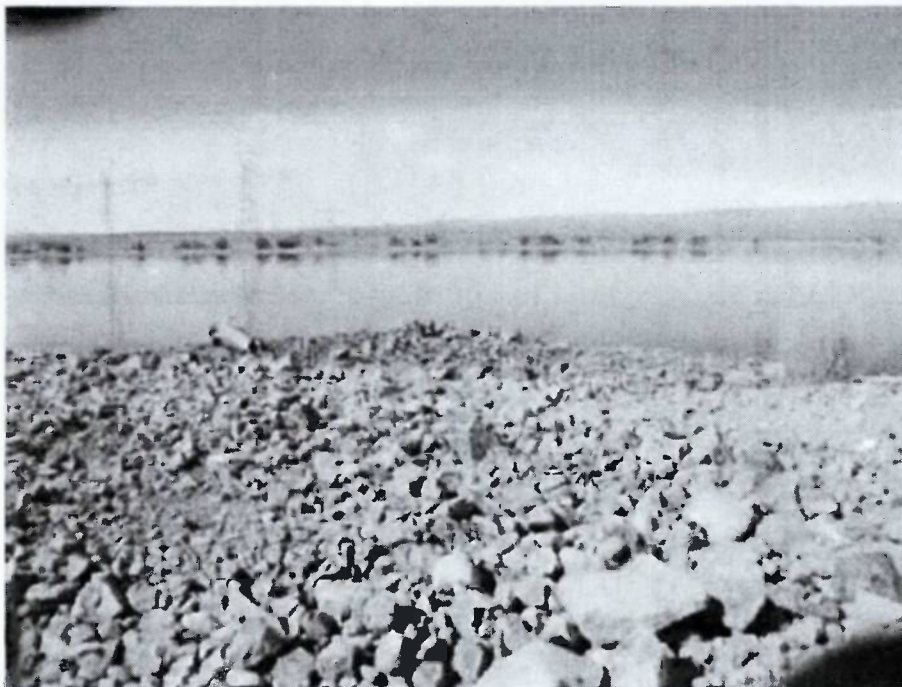
Photo 2. Southern anchor block area after rip rap replaced (facing west).

The areas where the barriers had been located were visually inspected for stains and anomalies. A copy of the inspection report is provided in Attachment 5. None were observed so the rip rap that had been removed to facilitate demolition was returned and spread to blend the appearance of the points consistent with the surrounding terrain as shown in Figure 4 (Attachment 2). Since the barriers had no radiological contamination, no post demolition surveys were performed using the global positioning environmental radiological surveyor (GPERS). No post-demolition global positioning system (GPS) surveys were performed since no below-grade excavations were required for removal.

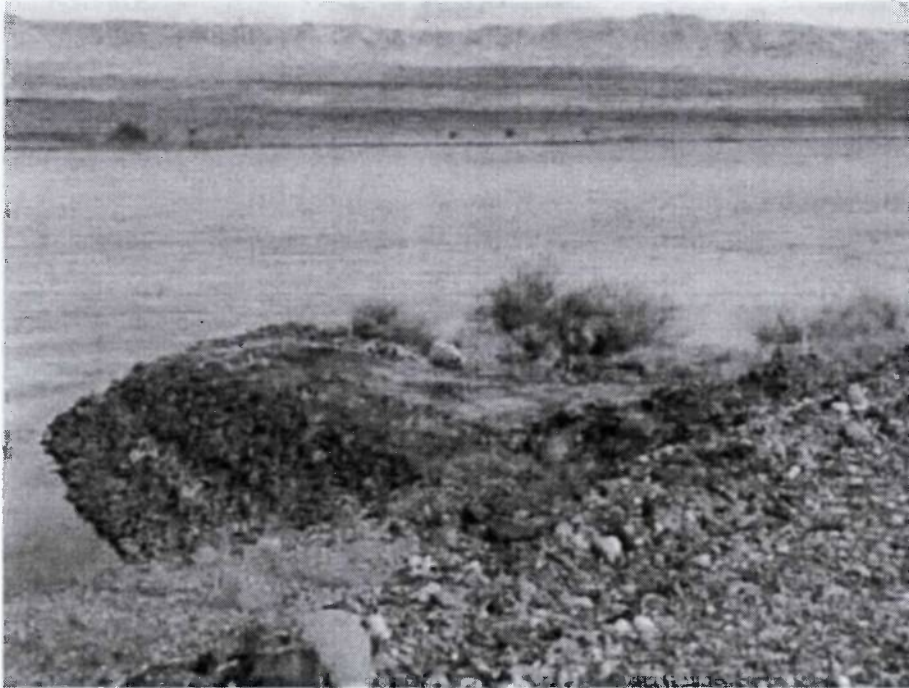
Photo 3. Location of former northern anchor block (facing northwest).

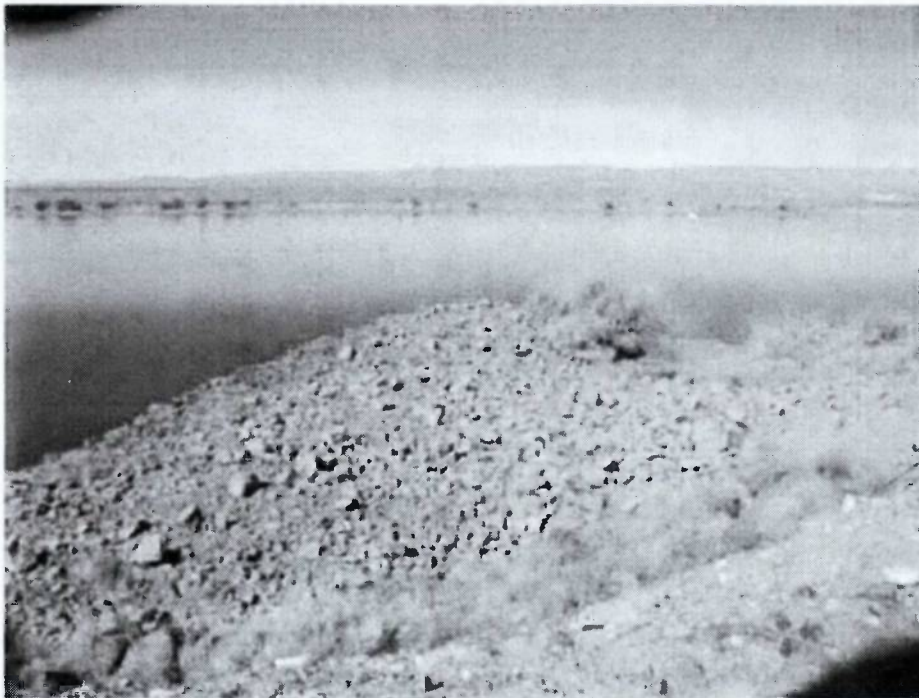
Photo 4. Northern anchor block area after rip rap replaced (facing northwest).
